Mine Safety and Health Administration 110 Gott Road Princeton, West Virginia 24740

February 4, 1981

Report on Investigation of Nonfatal Coal Mine Bump(s),

Beatrice Mine, Beatrice Pocahontas Company, Keen

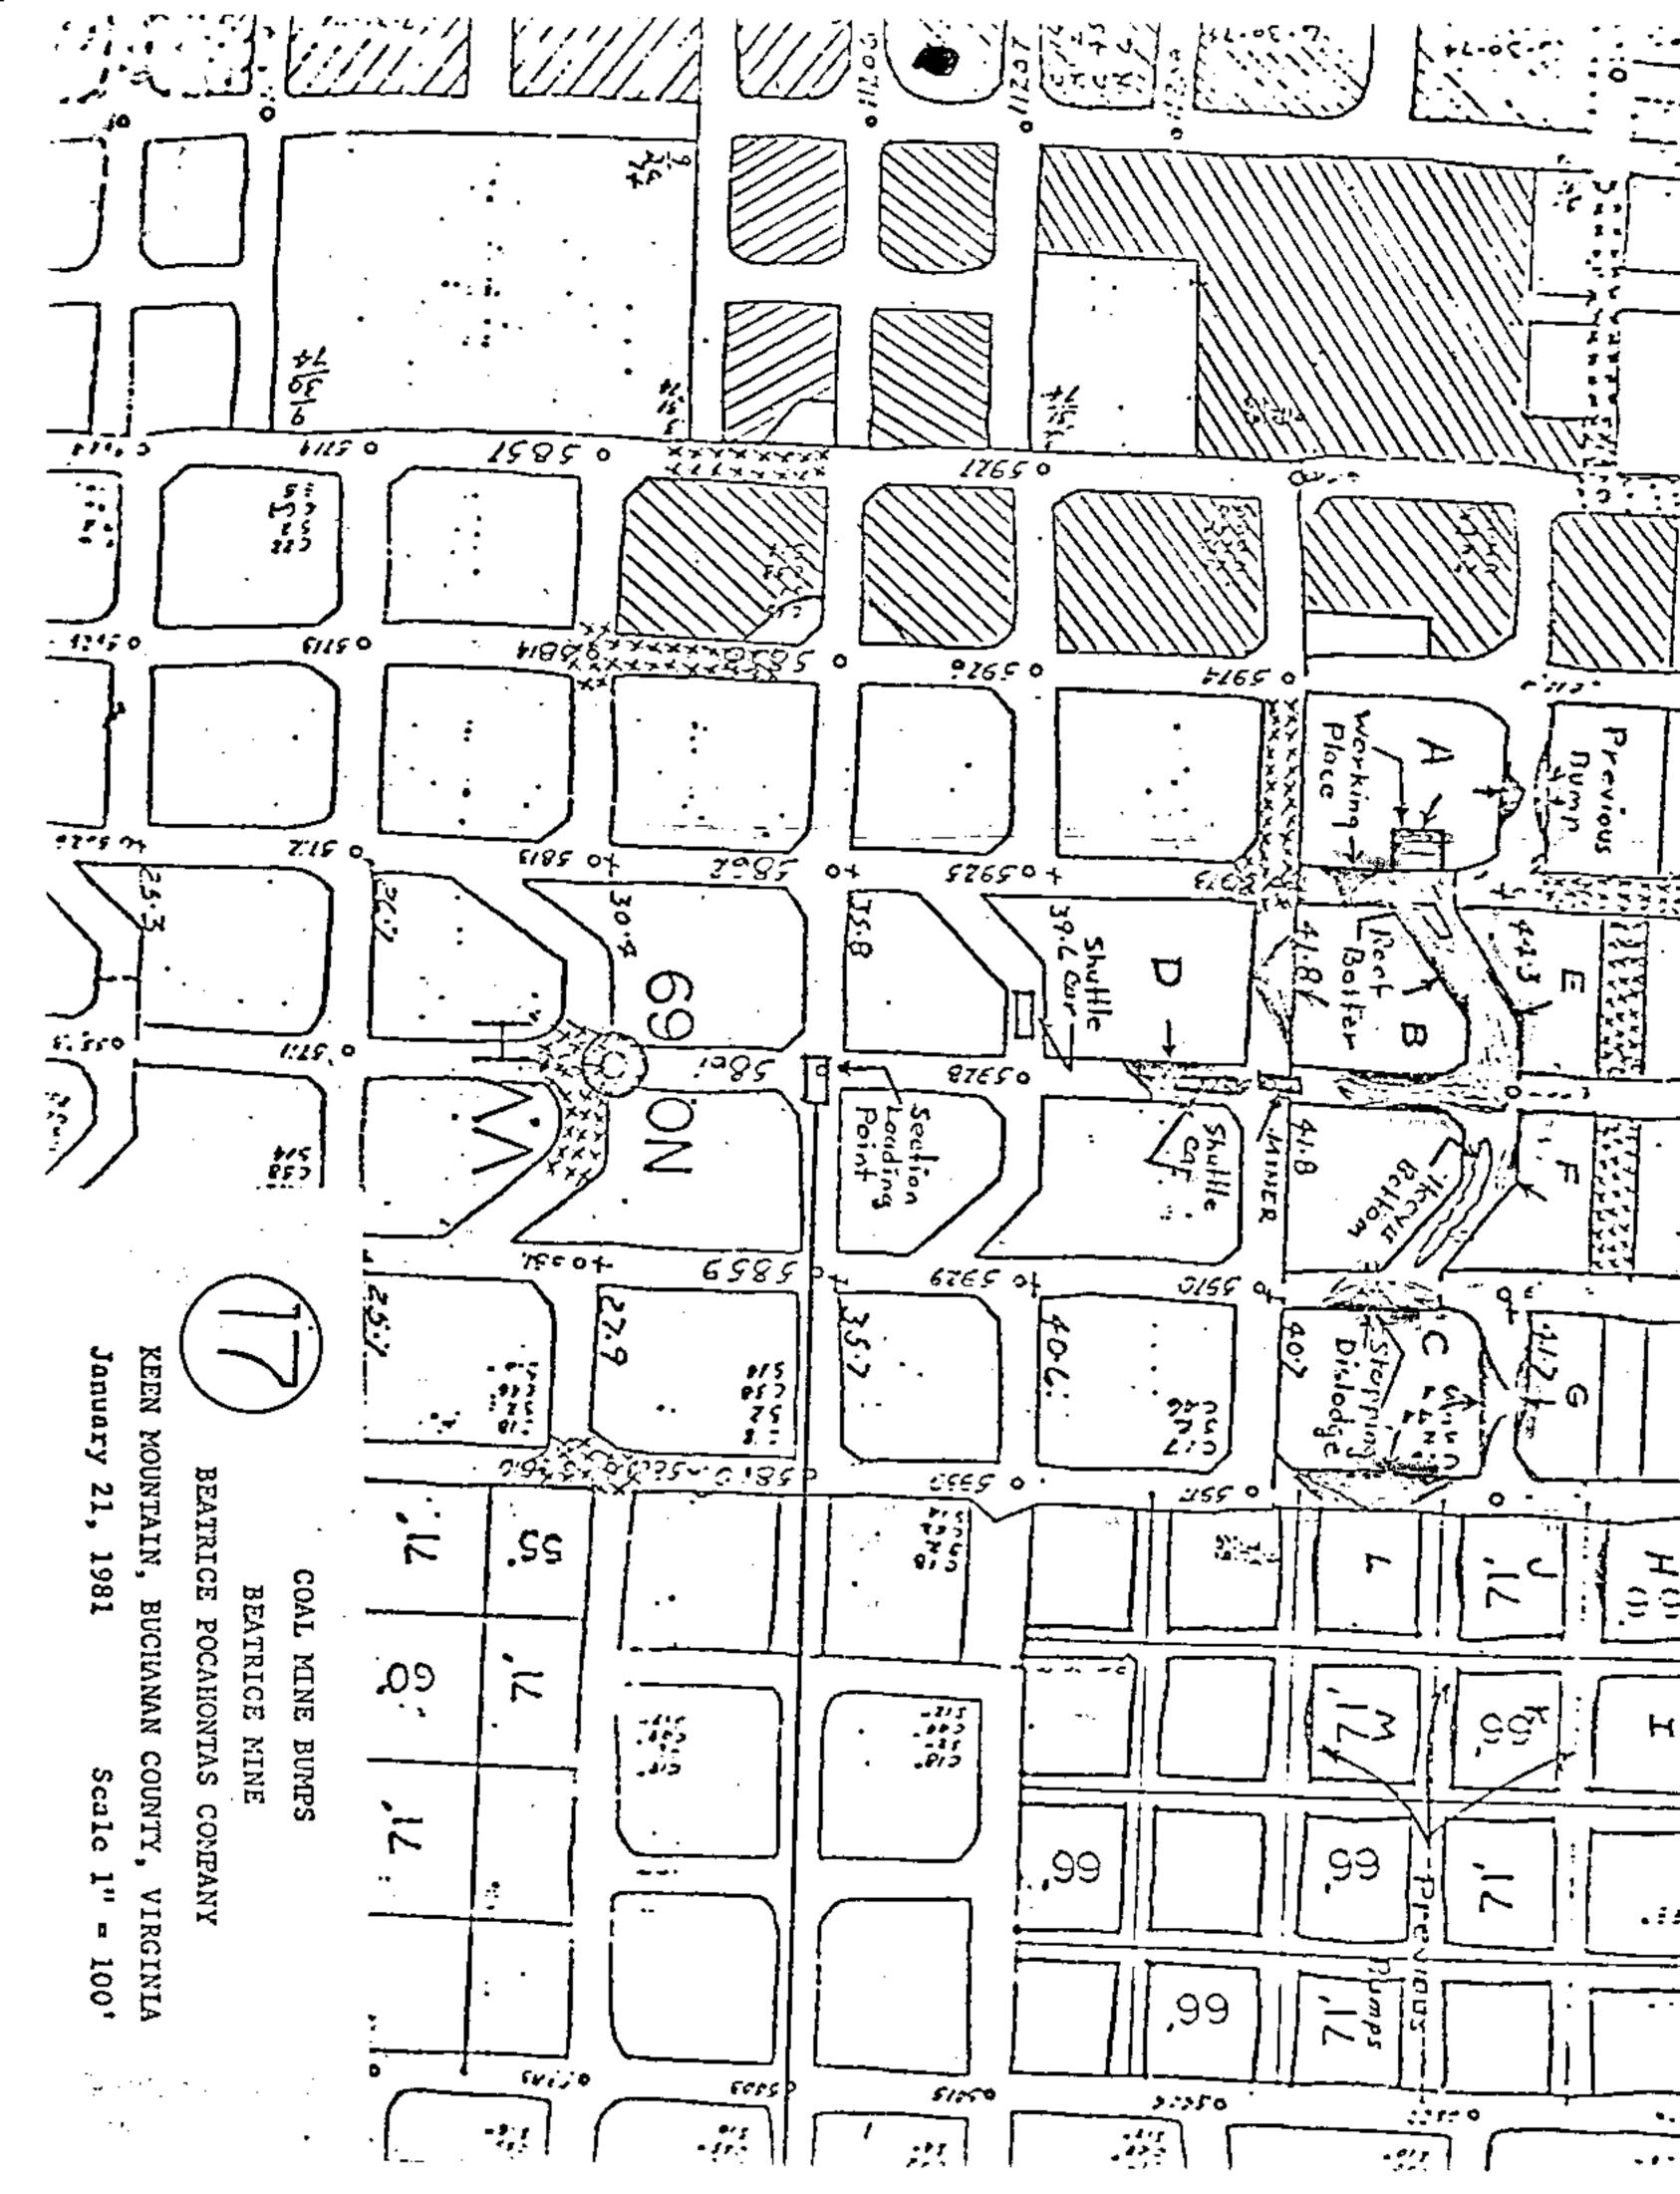
Attachment

The investigation revealed five chain pillars and three pillar remnants had erupted to some degree as a consequence of the bump(s), and one cinderblock stopping was torn out due to the expansion of the coal rib.

The attached mine print shows the specific area involved, the focus of the bump(s) locations where coal was expelled violently from pillars, area where the floor was affected, and the extent of extraction.

In pillars A, B, C, and D the force generated by the abrupt release of energy resulted in coal being expelled violently and in sufficient quantities to spread coal to a depth of approximately 2 feet across the openings (dark areas). As a result of the force, the working face (pillar "A") was expanded outward for a distance of 10 feet. The force generated in the pillar remnants E, F, and G was only minor reactions causing small amount of coal to be expelled from the ribs. These chain pillars (90x80 feet) had been split during the mining of the adjacent area to reduce the size of the pillars to avoid excessive pressure build-up in the pillar remnant for second mining.

It will be noted, that several pillar remnants and one pillar (70x100 feet) in size were abandoned in the pillared out area. The abandonment of these remnants was due to very hazardous roof conditions, and the pillar was abandoned because of its vulnerability to a violent coal outburst. Mining was being done in the maximum pressure zone (in the vertex of two pillared out areas) which make the pillars more vulnerable to coal mine bumps.
